NATIONAL TRANSPORTATION SAFETY BOARD
Vehicle Recorder Division
Washington, DC 20594

Onboard Image & Data Recorder

Group Chairman's Factual Report
By Sean Payne

Location:	Tempe, Arizona
Date:	March 18, 2018
Aircraft:	2017 Volvo XC90,
Operator:	Uber Technologies, Inc.
NTSB Number:	HWY18FH010

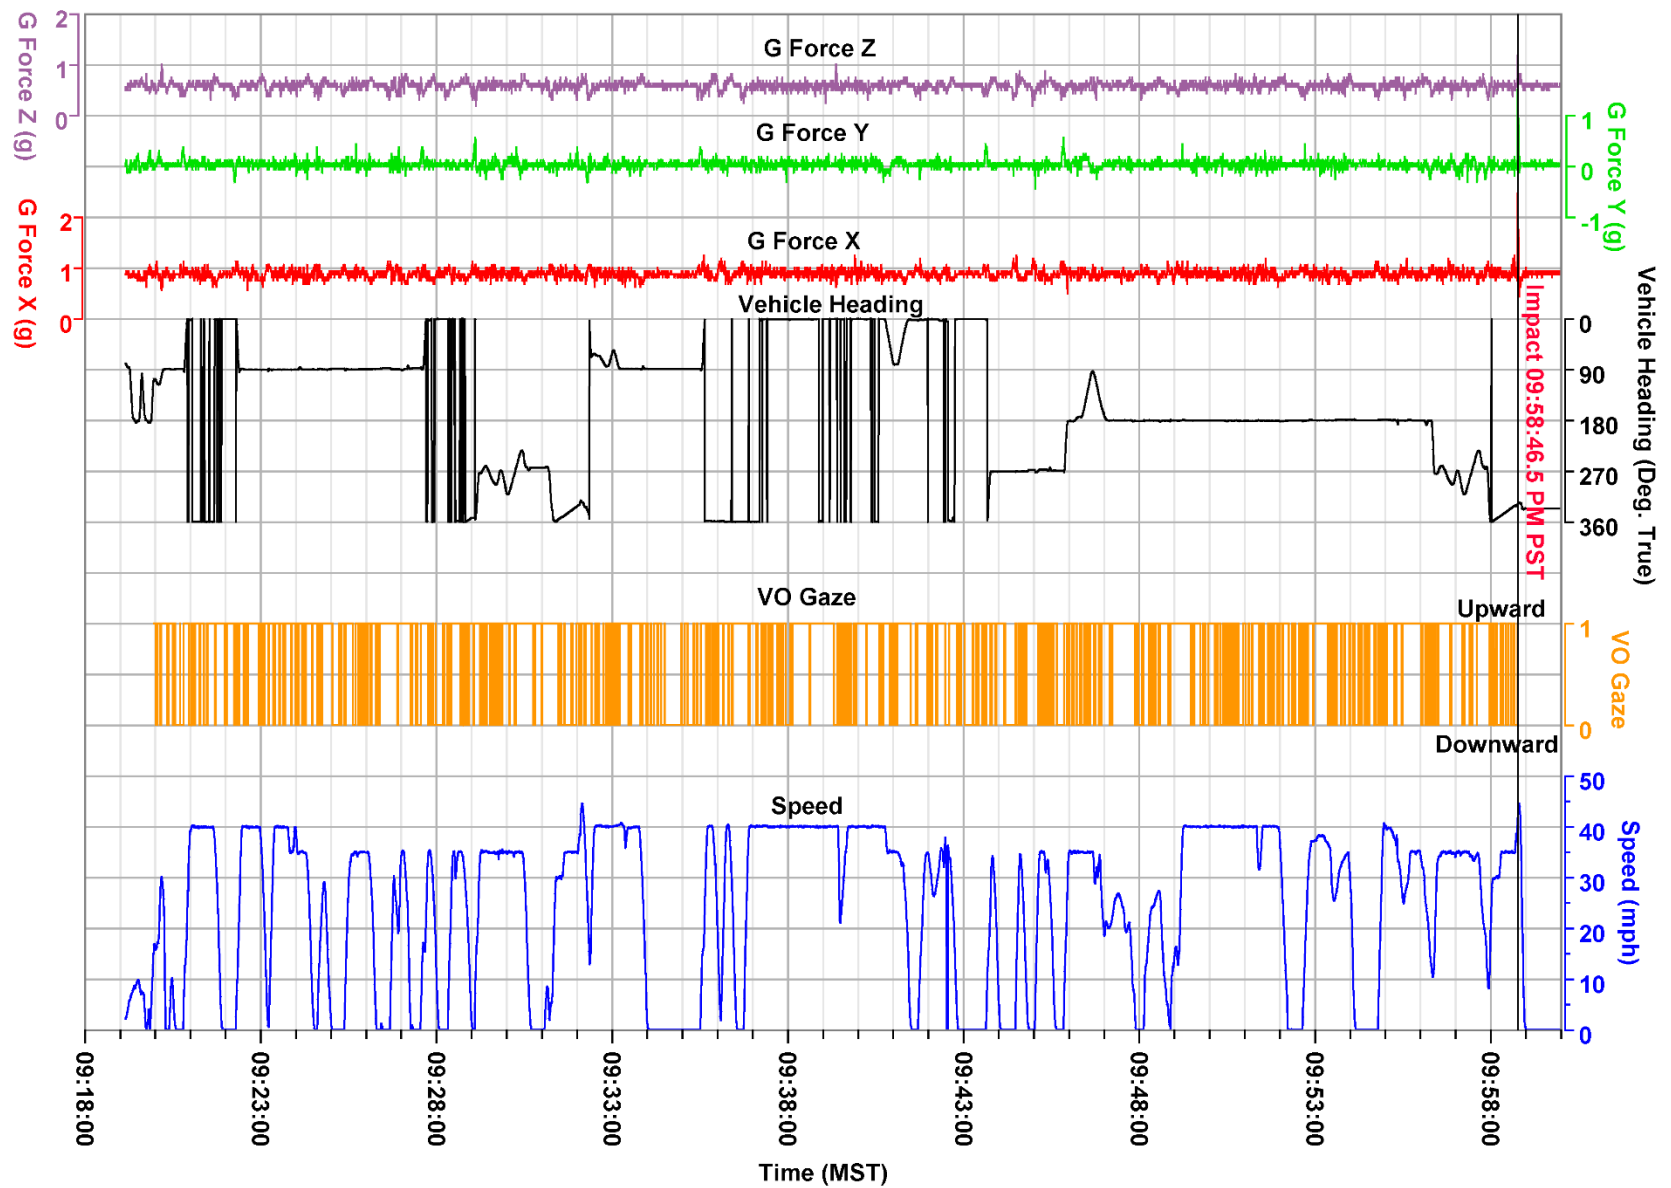
Figure 1. Select vehicle parameters and inward facing video data for the entire accident trip.

Figure 1 is a plot consisting of three-axis acceleration, vehicle heading, vehicle speed and VO gaze. The plotted time interval is from 9:18:00 PM to 10:00:00 MST.

Data was tabulated for the VO Gaze between 9:19:57.7 PM and 9:58:46.5 PM when impact occurred. In total, the VO's gaze was tabulated for 38 minutes and 48.8 seconds of the accident trip. Of the 38 minutes and 48.8 seconds, GPS data indicated the vehicle was stopped for 7 minutes and 15.43 seconds. The total time the vehicle was moving was 31 minutes and 33.37 seconds. During the time the vehicle was moving, the VO's Gaze was classified as "downward" 245 times for a total of 10 minutes and 46.2 seconds. In total, while the vehicle was moving

and on a public roadway, the VO had her gaze “downward” approximately 34.1% of the time. The average amount of time the VO spent with her gaze downward was 2.56 seconds. The maximum duration the VO diverted her gaze downward was 26.47 seconds and occurred at 9:31:05 MST when the vehicle was traveling west on Salado Pkwy and then north along N. Mill Ave. across the N. Mill Ave bridge where the accident would later occur on the VO’s next circuit through Tempe.

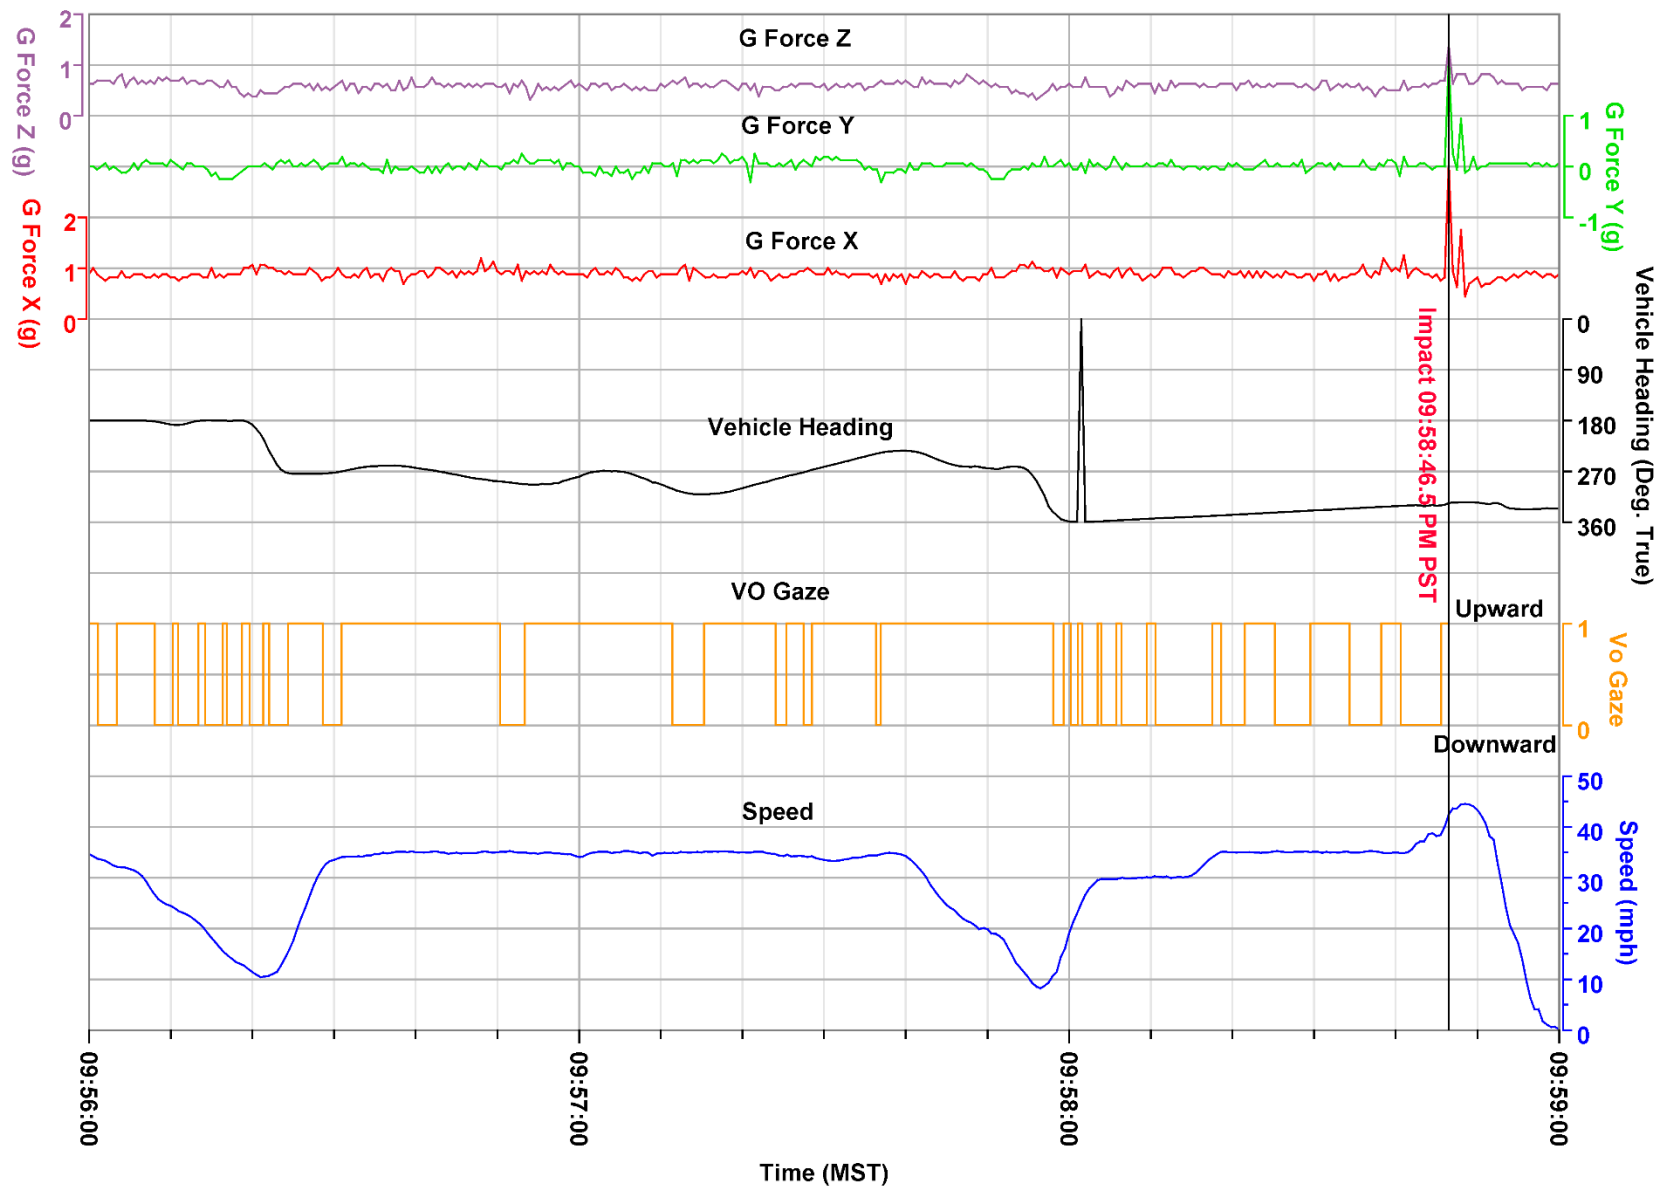
Figure 2. Select vehicle parameters and inward facing video data for approximately three minutes prior to impact.

Figure 2 is a plot of the same parameters for a plotted time interval between 9:56:00 and 9:59:00 PM PST, approximately 3 minutes prior to the accident time. From 09:56:00 until the accident, the VO’s gaze was classified as “downward” 23 times, for a total of 58.43 seconds of the 2 minutes and 46.5 seconds prior to impact.

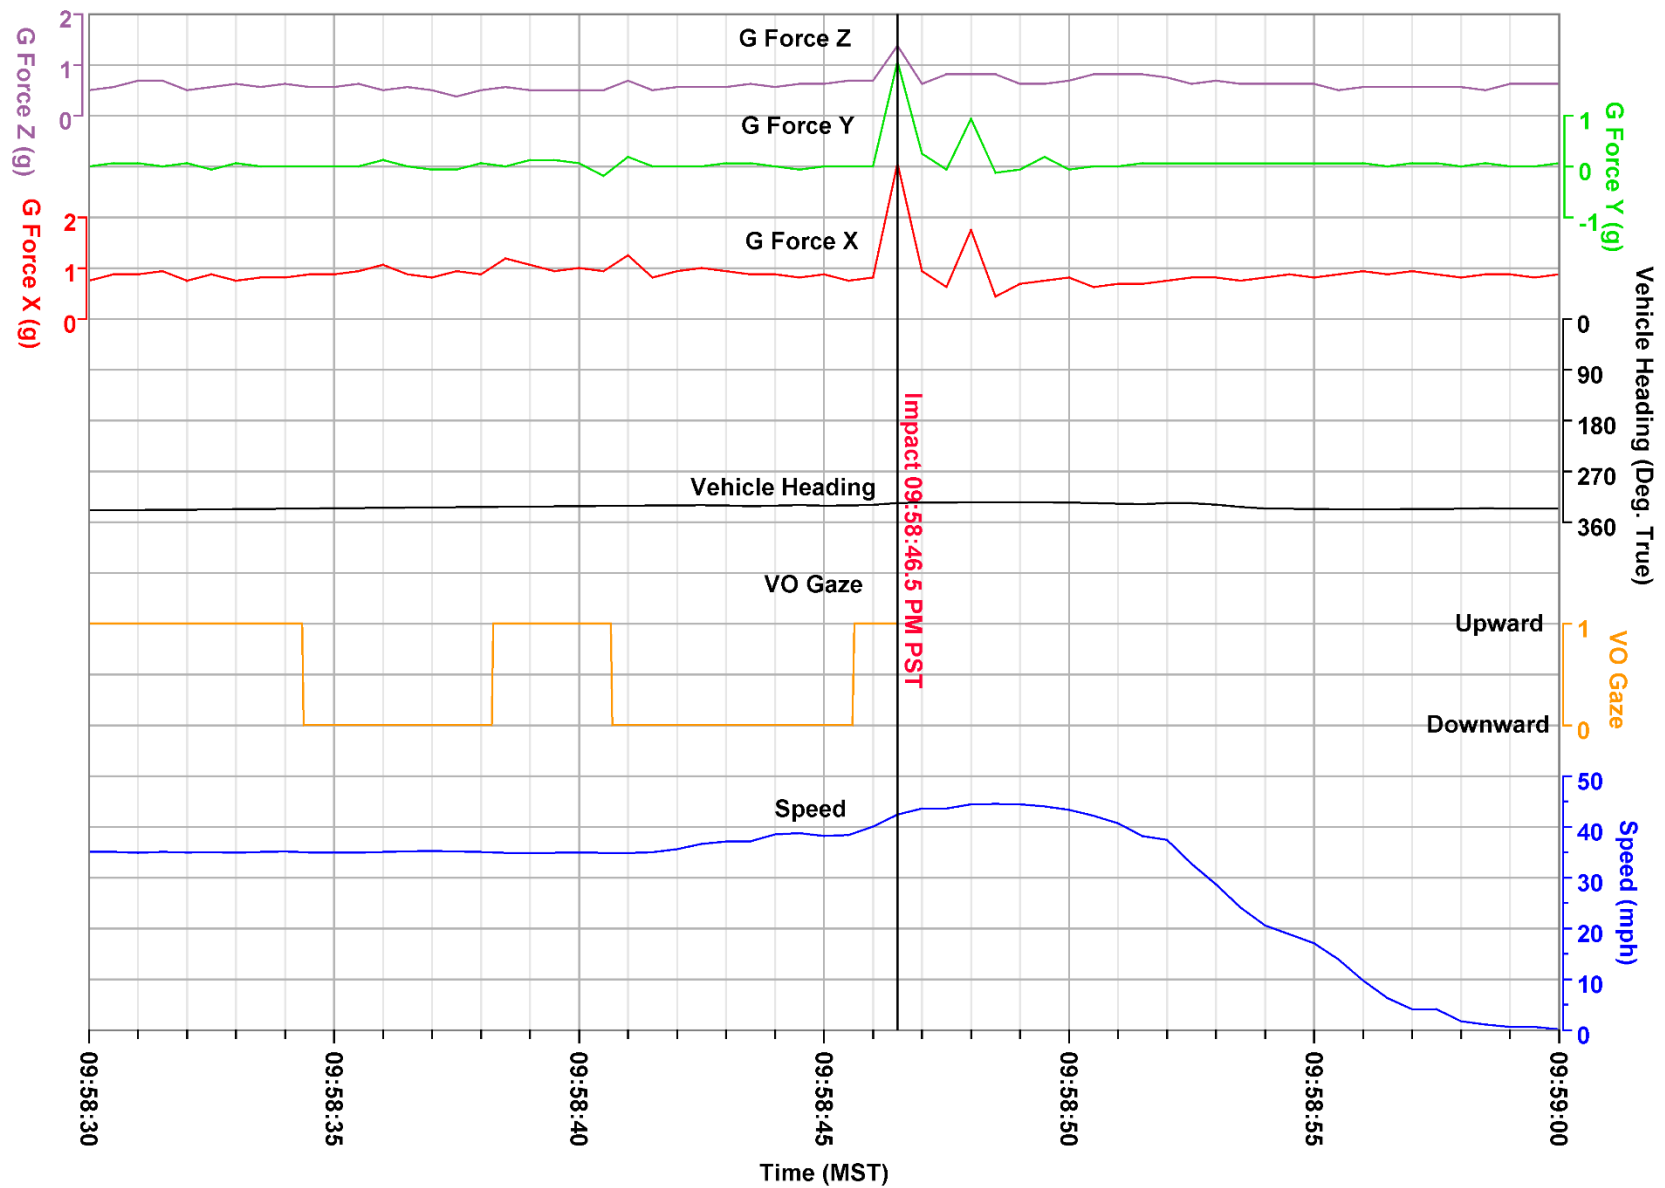
Figure 3. Select vehicle parameters and inward facing video data for approximately thirty seconds prior to impact.

Figure 3 is a plot of the same parameters for a plotted time interval between 9:58:30 and 9:59:00 PM PST.

9:58:46.2: VO reacted abruptly while looking forward of the vehicle.

9:58:46.5: Impact occurred.

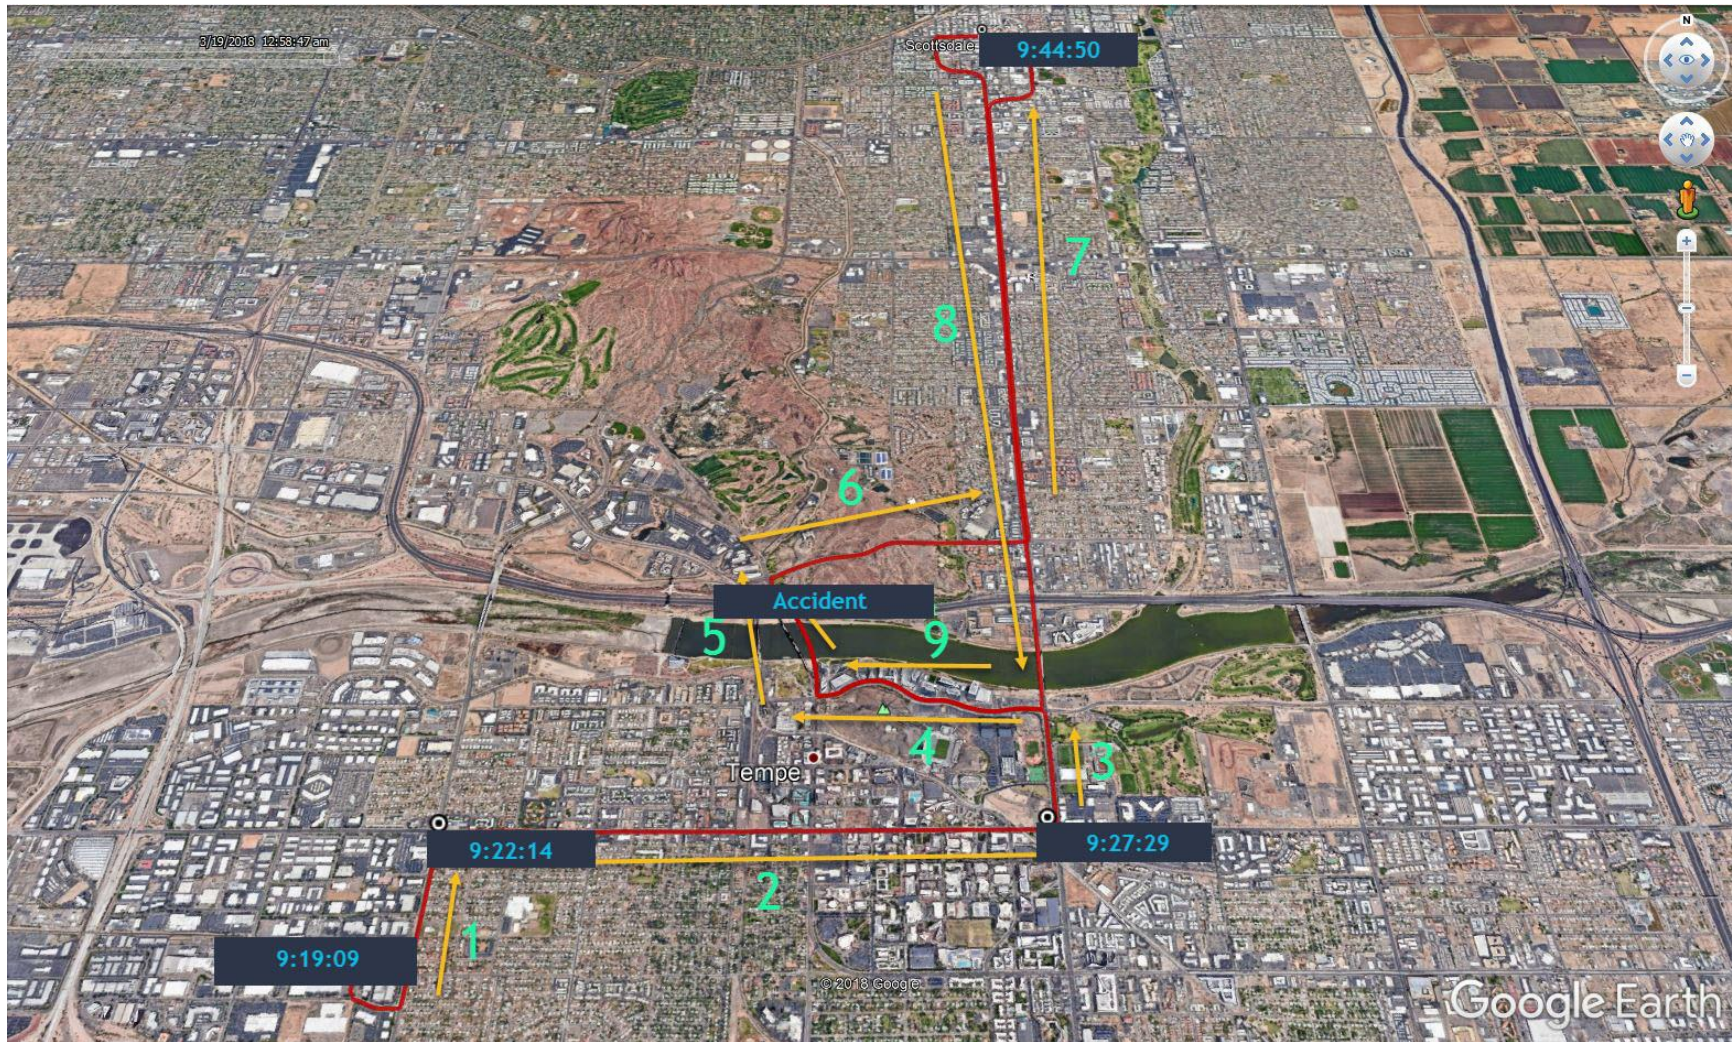
Figure 4. An overview of the vehicle's entire trip on the night of the accident.

Figure 4 is a Google Earth overlay showing the entire accident trip. Since the route was a circuit, the graphic has been annotated with arrows pointing in the direction of travel of the vehicle as well as corresponding numerical leg segments.

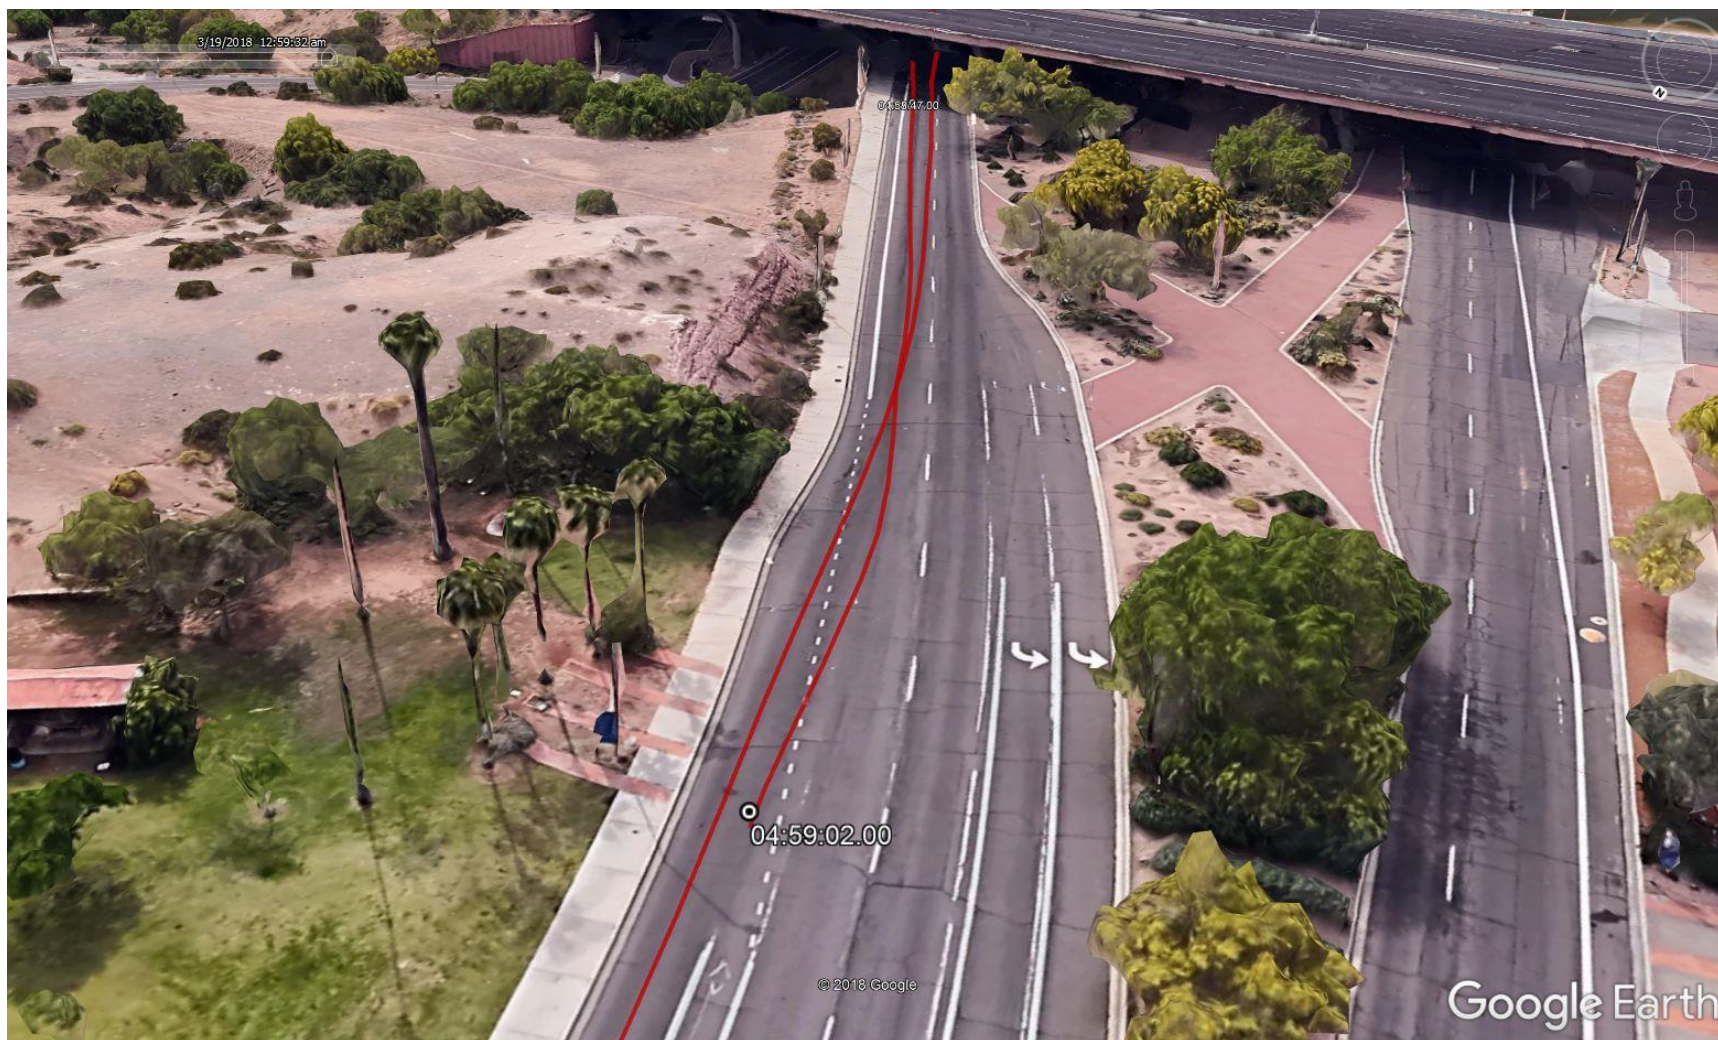
Figure 5. An overview of the vehicle's tracks in the vicinity of the accident.

Figure 5 is a Google Earth overlay showing the region of the accident on N. Mill Ave. The track on the left was the previous circuit made by the vehicle. The track on the right is annotated with times and indicates approximately when the vehicle crossed under the underpass on N. Mill Ave and when it came to a stop around 09:59:02.

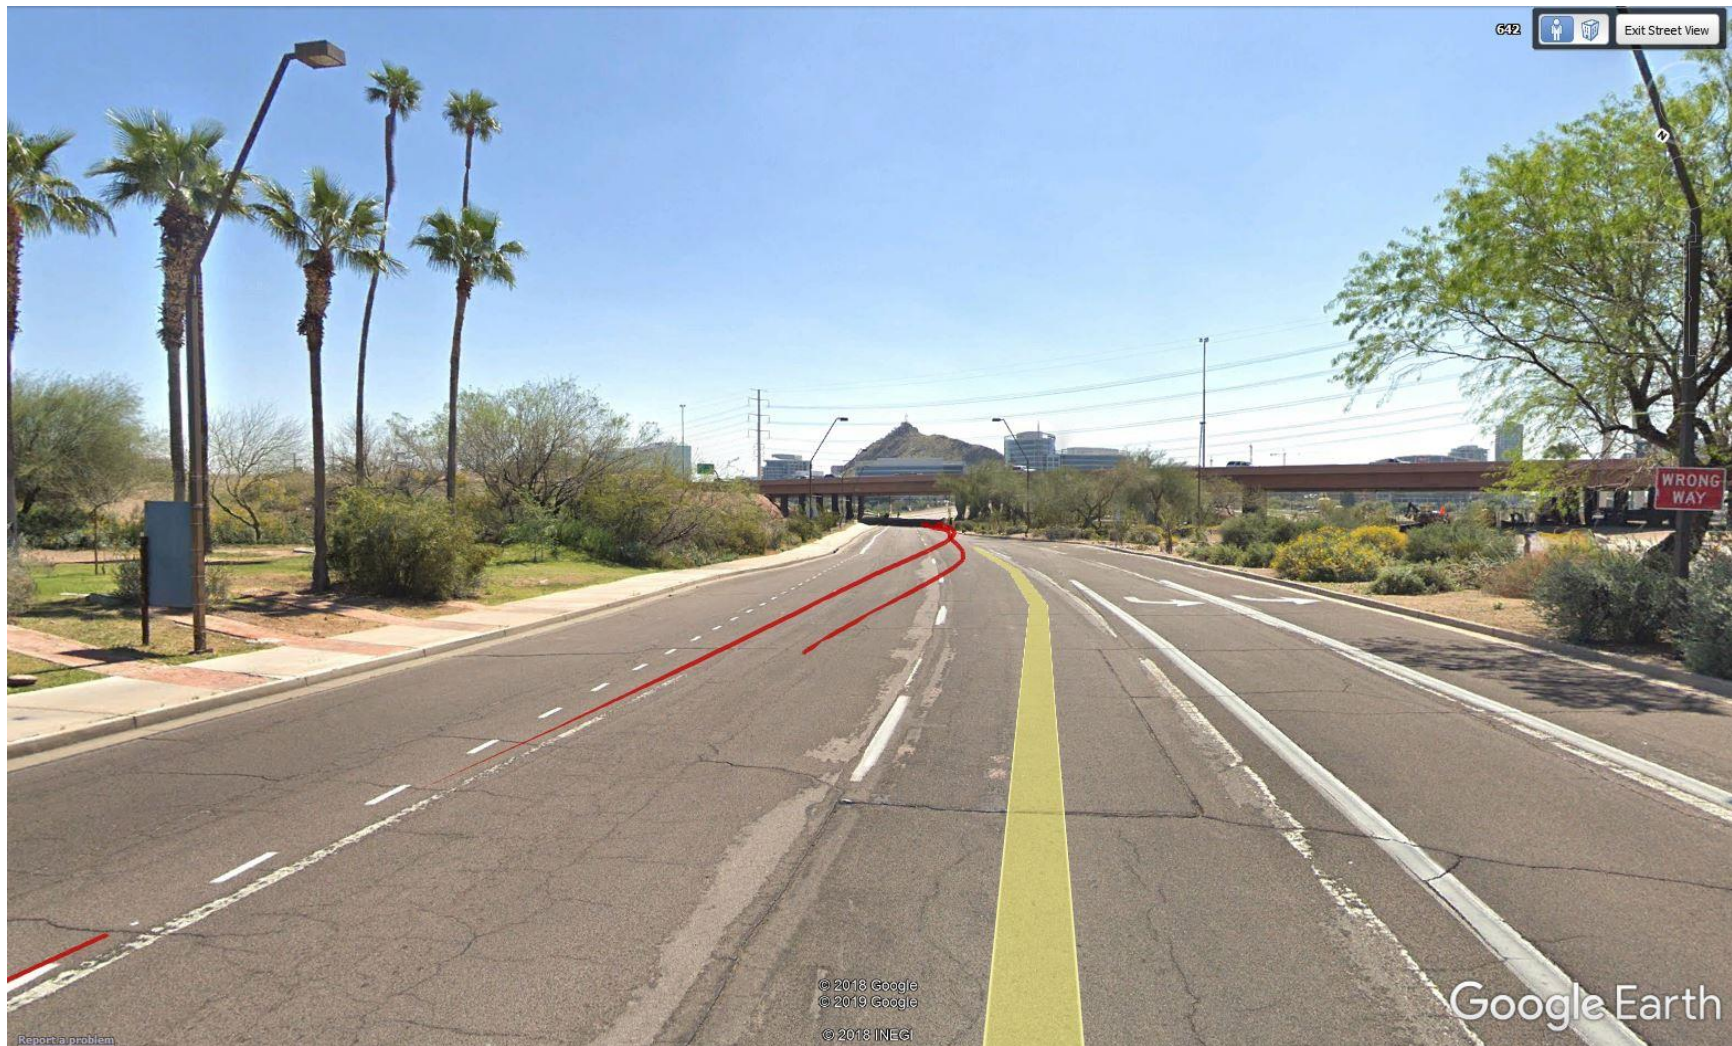
Figure 6. A representation of the vehicle's path on Google Earth Street View.

Figure 6 is a representation of the accident vehicle path as displayed on Google Earth Street View. The view is oriented looking south on N. Mill Ave. The track on the left was the previous circuit made by the vehicle. The track on the right was the vehicle’s path around the time of impact with the pedestrian.
